# **Resilient Buildings** From Vulnerabilities to Opportunities

The LEED Platinum, LBC-certified, resilient Brock Environmental Center, Virginia Beach - photo: SmithGroupJJR Local Solutions: Eastern Regional Climate Preparedness Conference April 4, 2016

Alex Wilson, President Resilient Design Institute Founder, BuildingGreen, Inc.

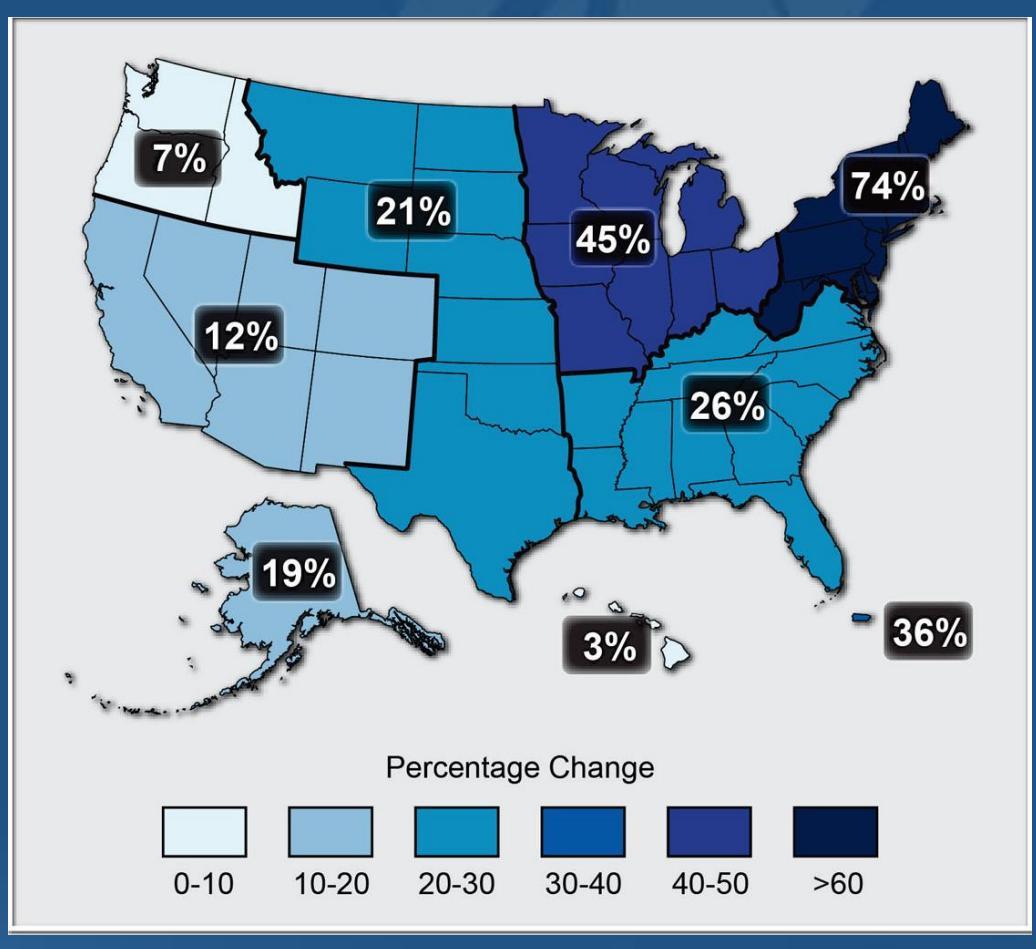
- 74% increase in intense storms in the Northeast from 1958 – 2011
- Similar trend in other regions—though not as extreme
- Even in areas where there may be less total rainfall, it is coming in more intense storms
- Causes river valley as well as coastal flooding

Percent increase in very heavy precipitation 1958-2011 (defined as the heaviest 1% of all events). Source: Nat'l Climate Assessment Draft (January 2013)

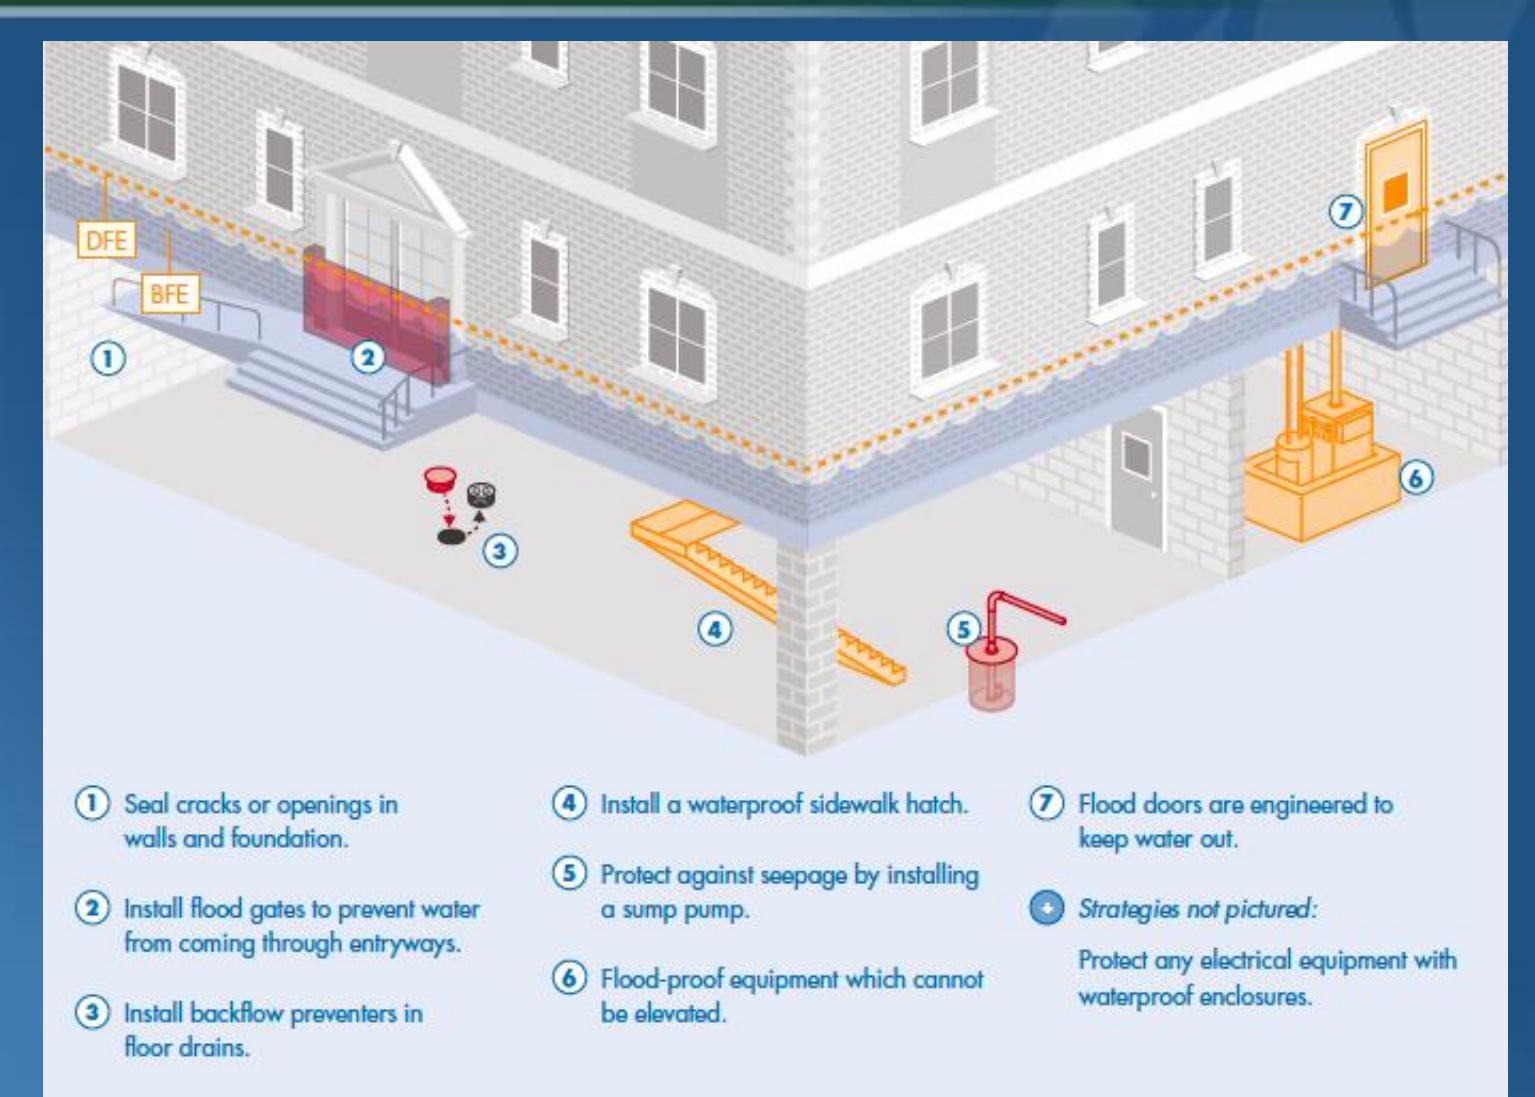
#### Dry floodproofing

Enterprise Community Partners – Strategies for Multifamily Building Resilience

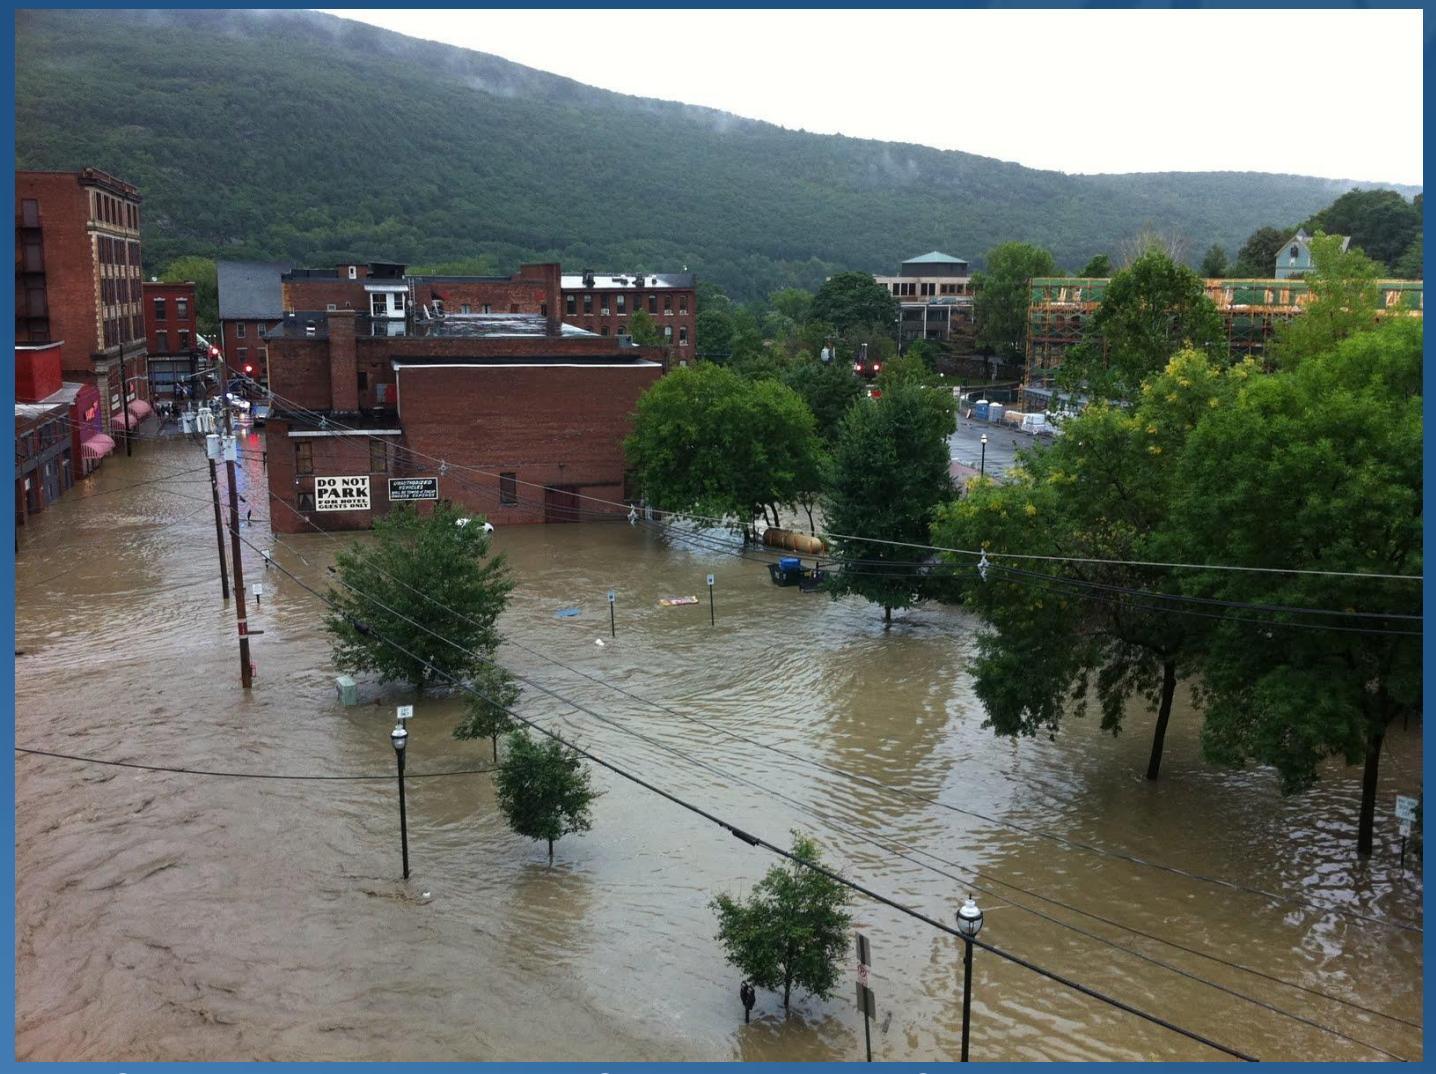
Flat Street, Brattleboro, Vermont, Sept, 2011. Photo: Charlie Boswell

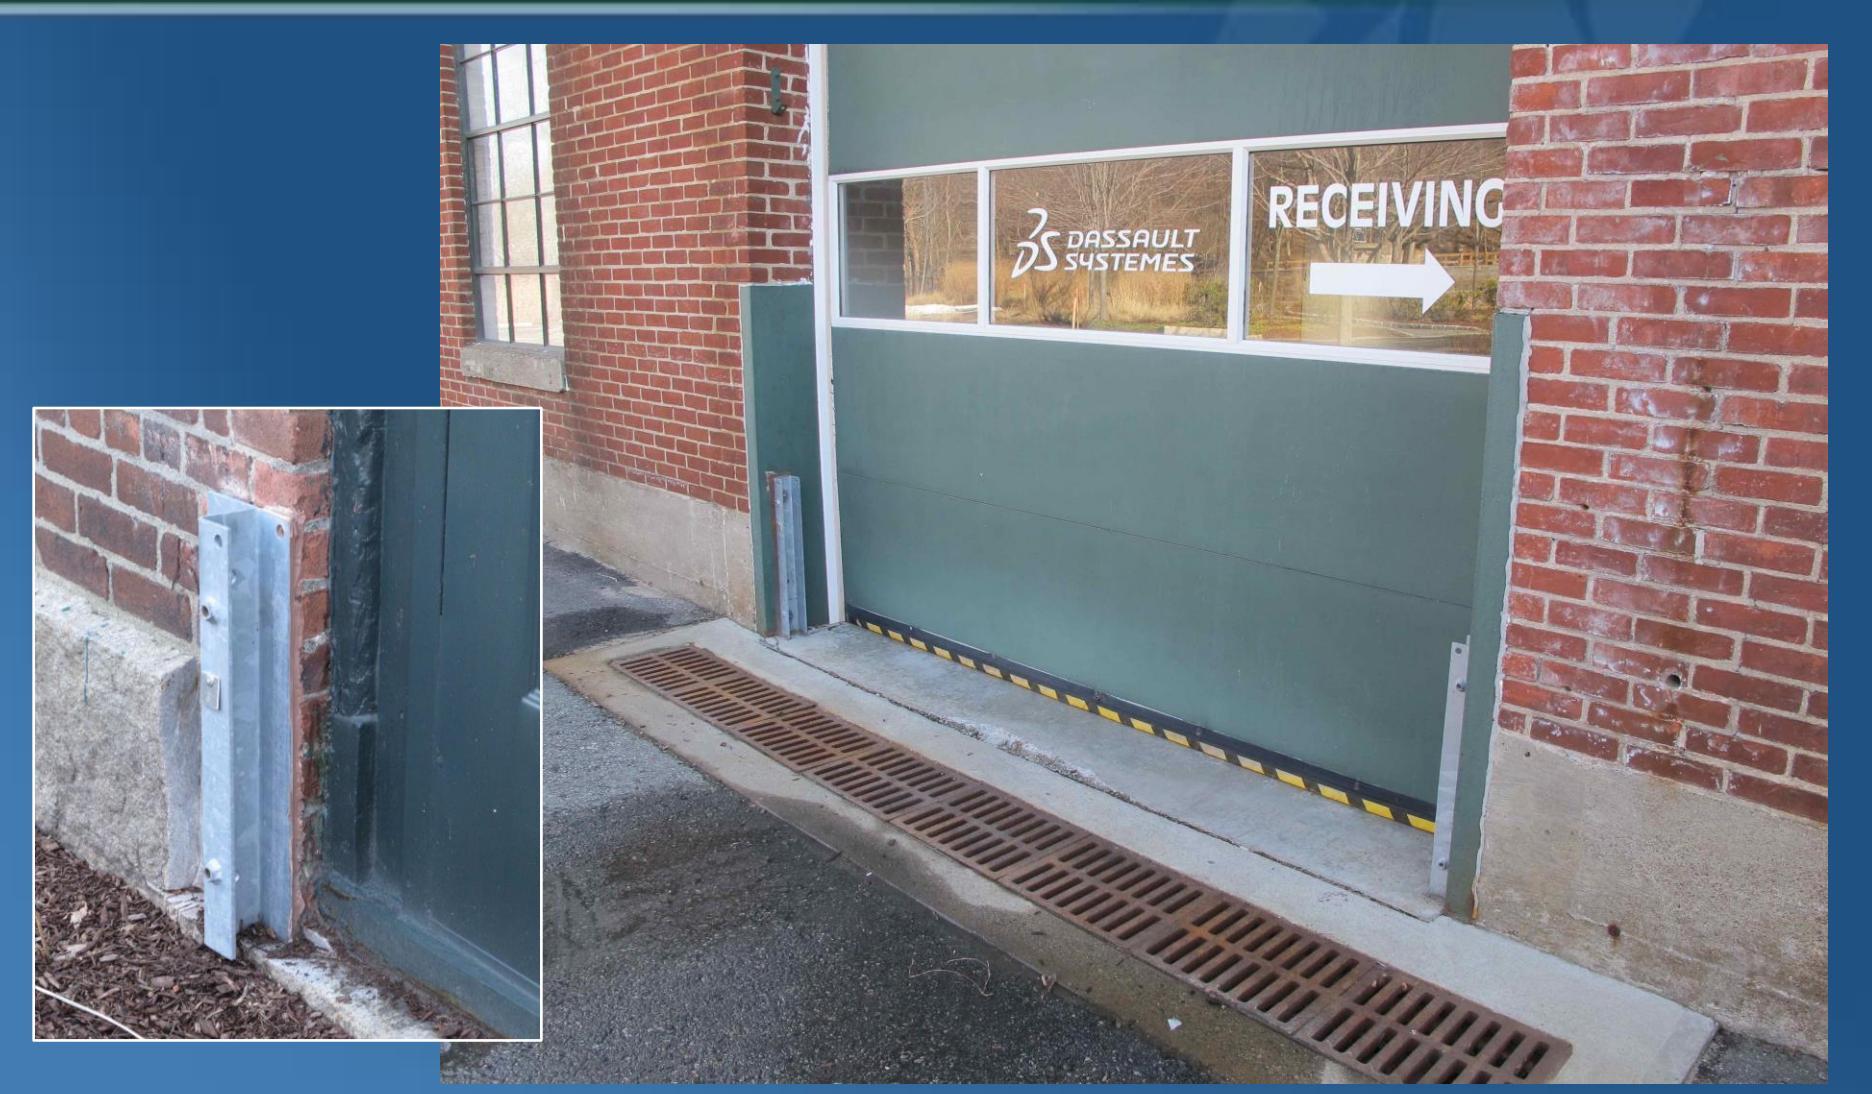
Flood barrier on a commercial building in Providence. Photo: Alex Wilson

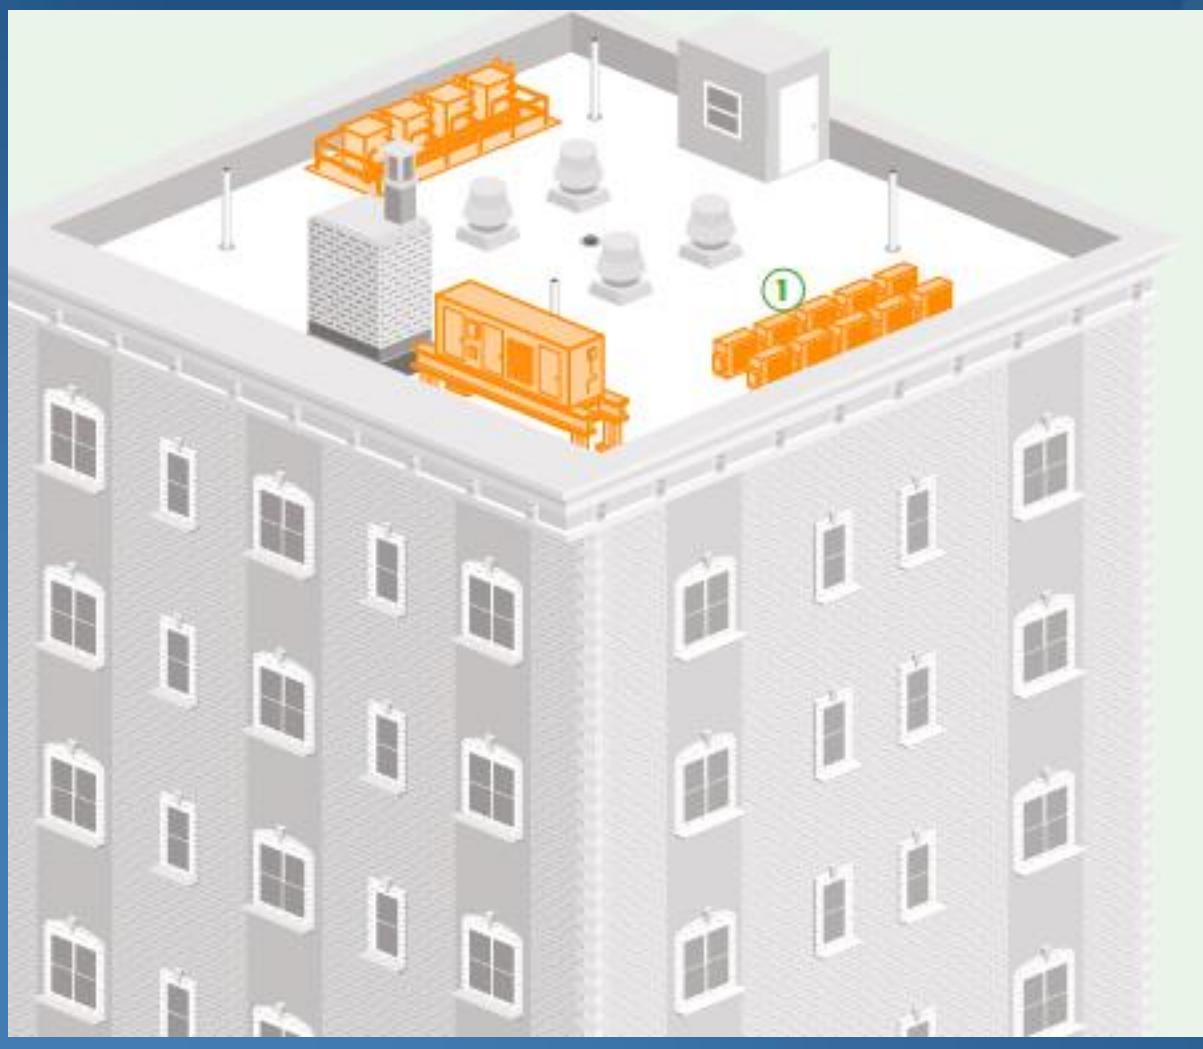
Relocate mechanical equipment to upper floors or roof.

- (2) For equipment that cannot be relocated, elevate in place above the Design Flood Elevation
- Strategies not pictured:

Relocate electrical systems above the Design Floor Elevation.

Anchor or elevate fuel storage tanks.

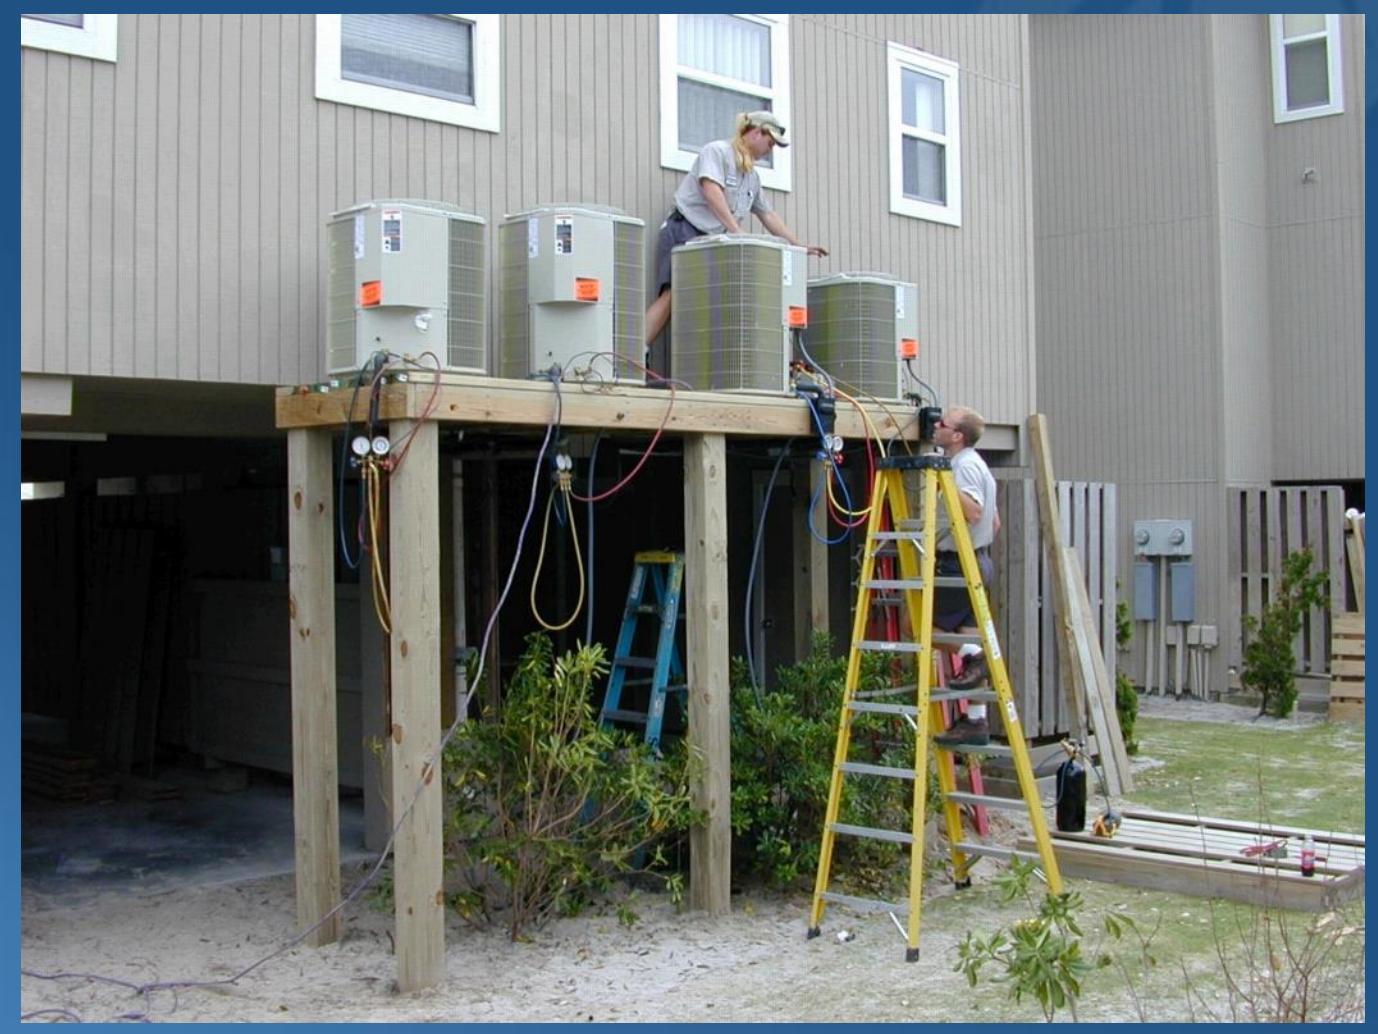
Elevating mechanical equipment in Carolina Beach, North Carolina in 1999 - Photo: Dave Saville, FEMA

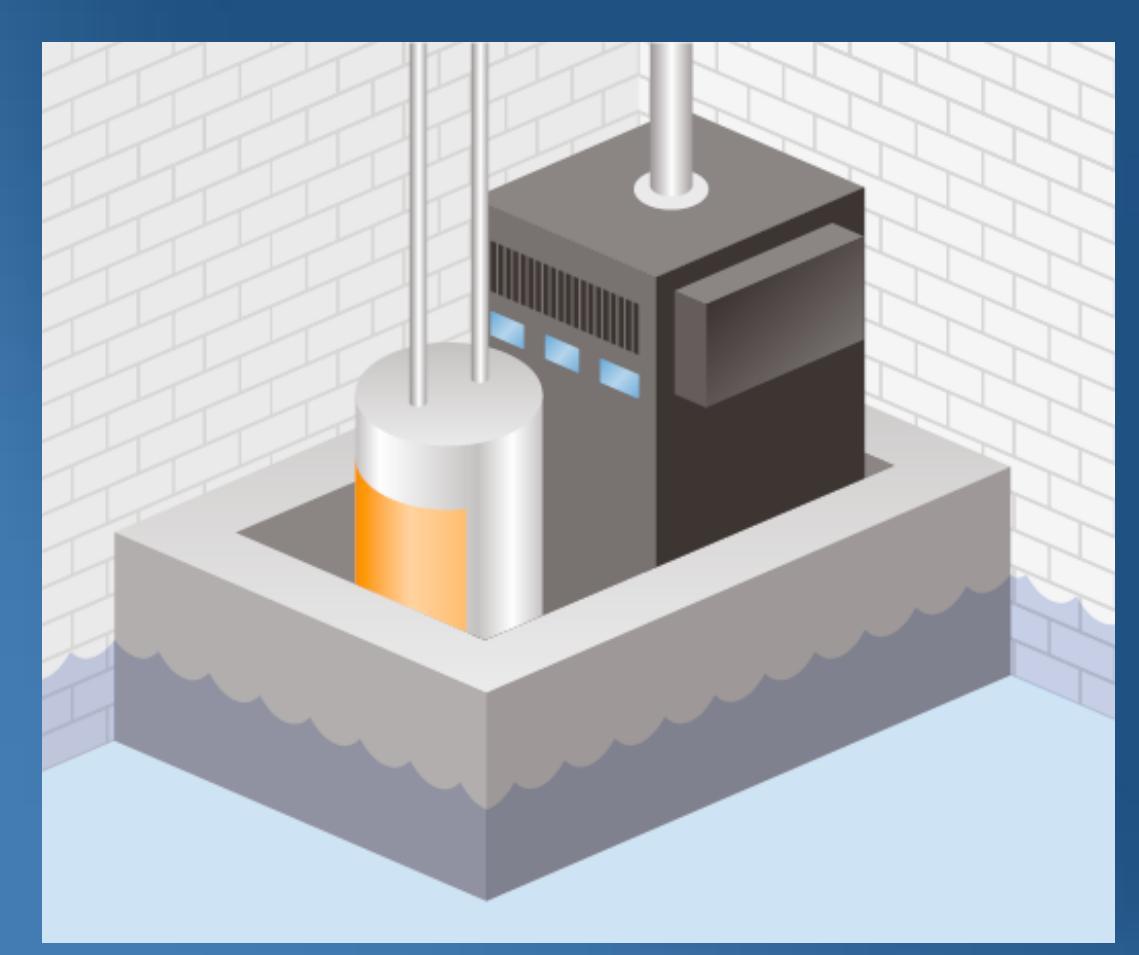
3' flood barrier around mechanical equipment Enterprise Community Partners – Colin Hayes

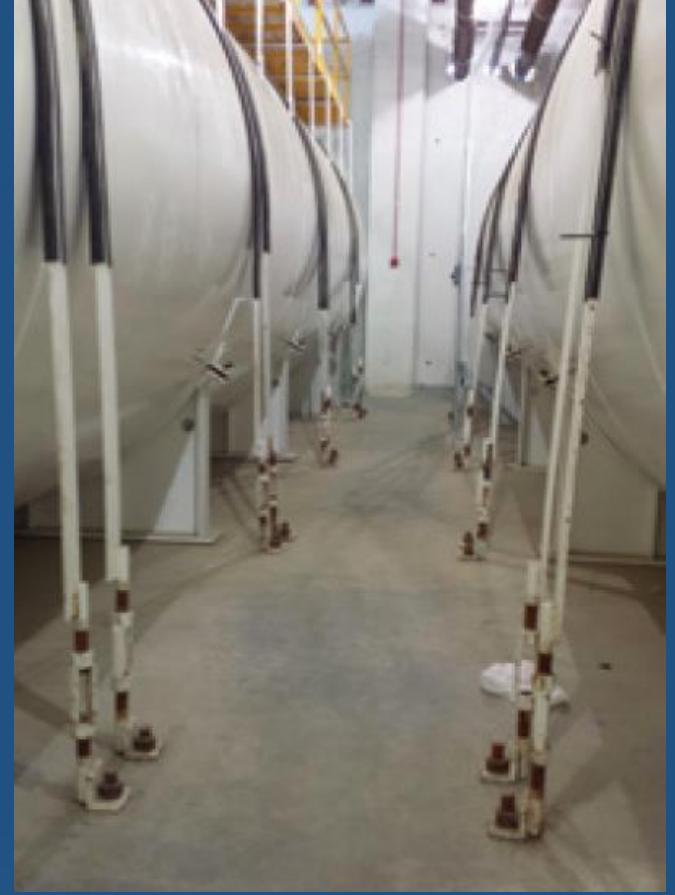
Fuel tank tie-downs anchored to concrete slab – photo: Jon Gravelin

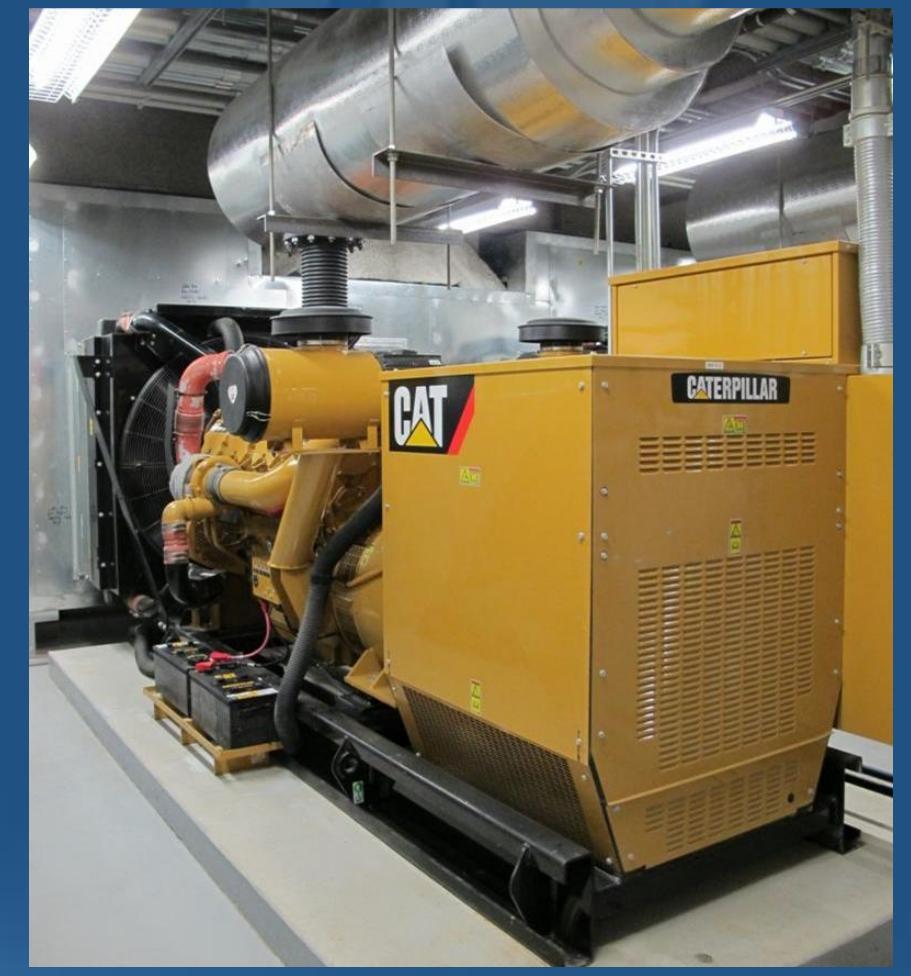
- Utility service in penthouse floor
- Rooftop CHP system
- Chillers, air handlers, ventilation, boilers in two penthouse floors
- Two back-up generators in penthouse - either could operate hospital
- Most diesel fuel stored in basement - bunkerized

Spaulding Rehab Hospital - Photo: Alex Wilson

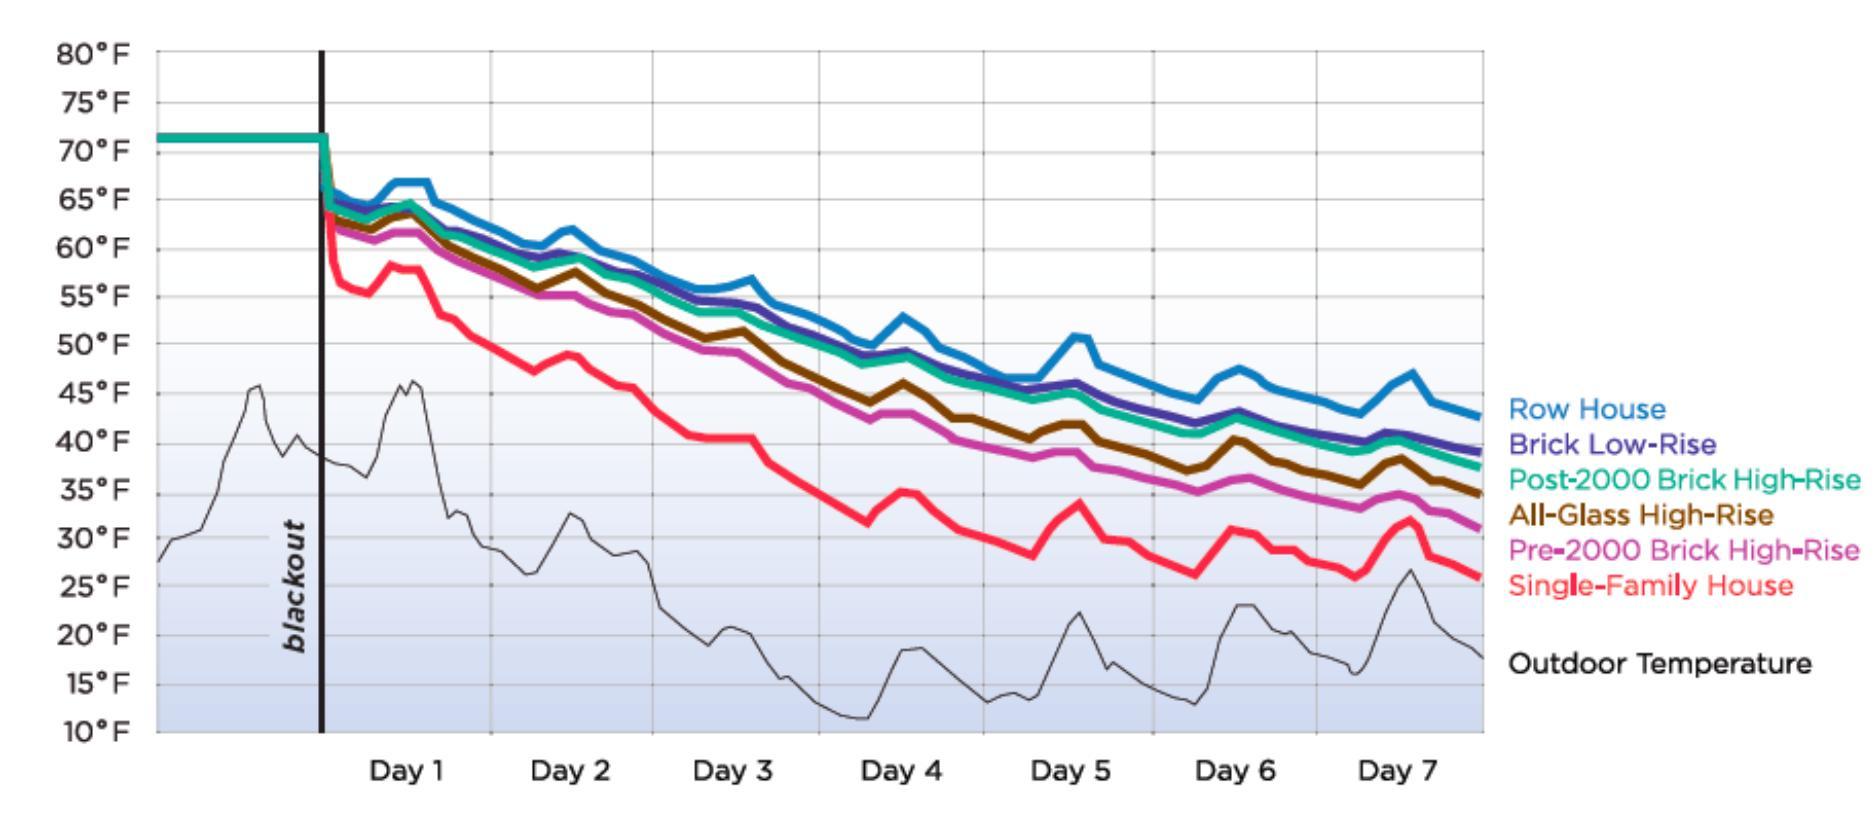
#### **Typical Building**

Temperature modeling by Atelier Ten for the report "Baby It's Cold Inside," Urban Green, NYC

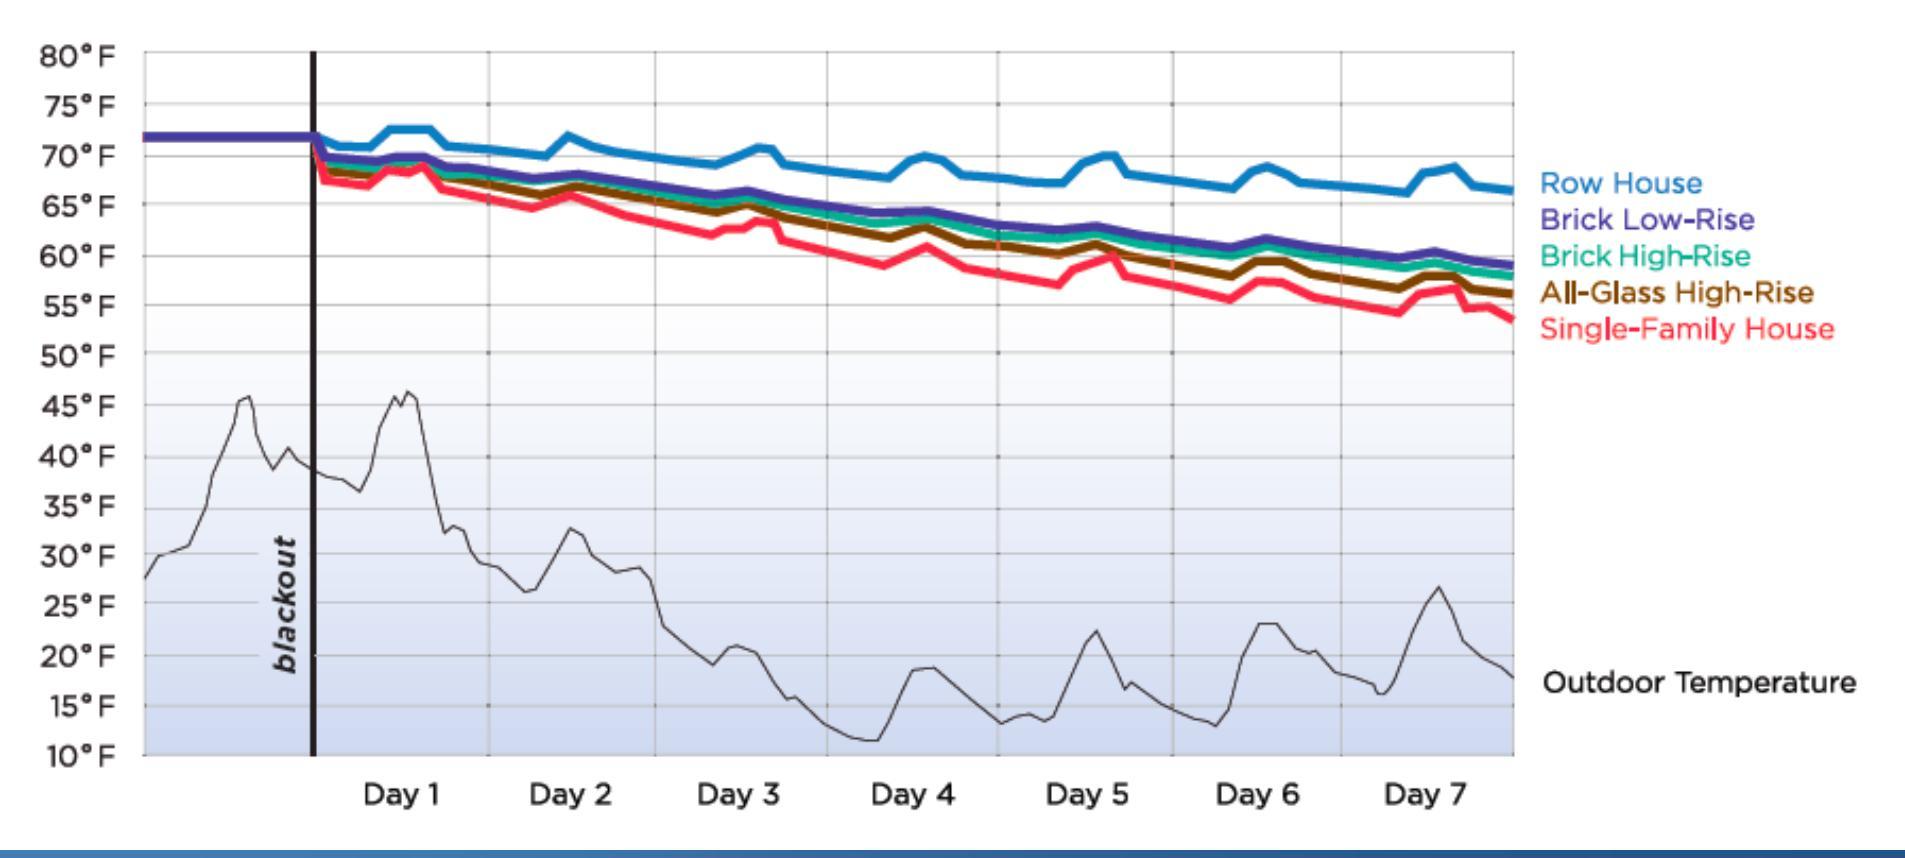
#### **High-Performing Building**

Temperature modeling by Atelier Ten for the report "Baby It's Cold Inside," Urban Green, NYC

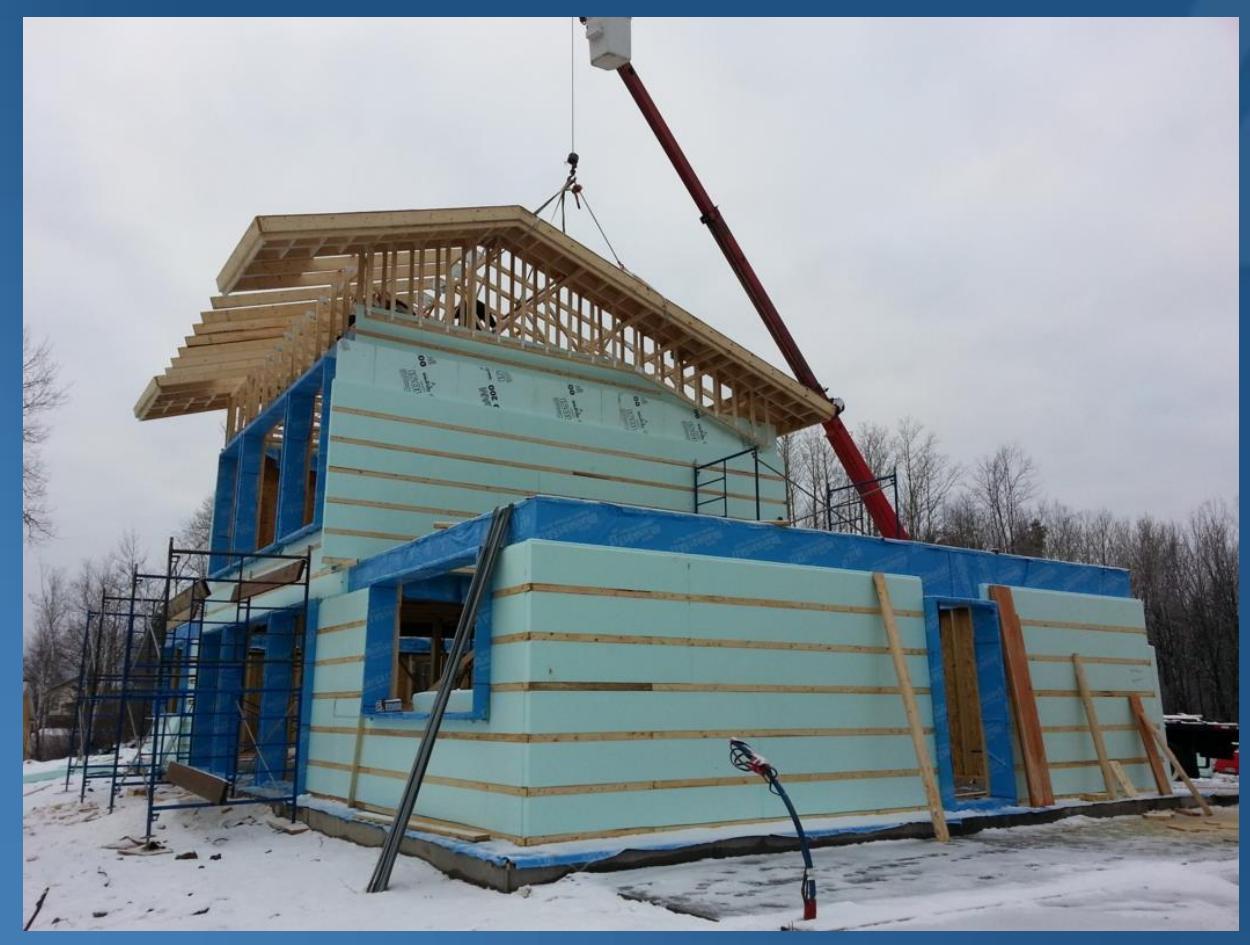
Kenogami House in Northern Quebec. Photo: Alain Hamel

- Extremely high insulation levels:
  - R-80 walls and foundation walls
  - R-64 floor

- R-150 roof
- Triple-glazed, dual-low-e, high-SHGC windows
  - Tighter than Passive House (0.5 ACH<sub>50</sub>)

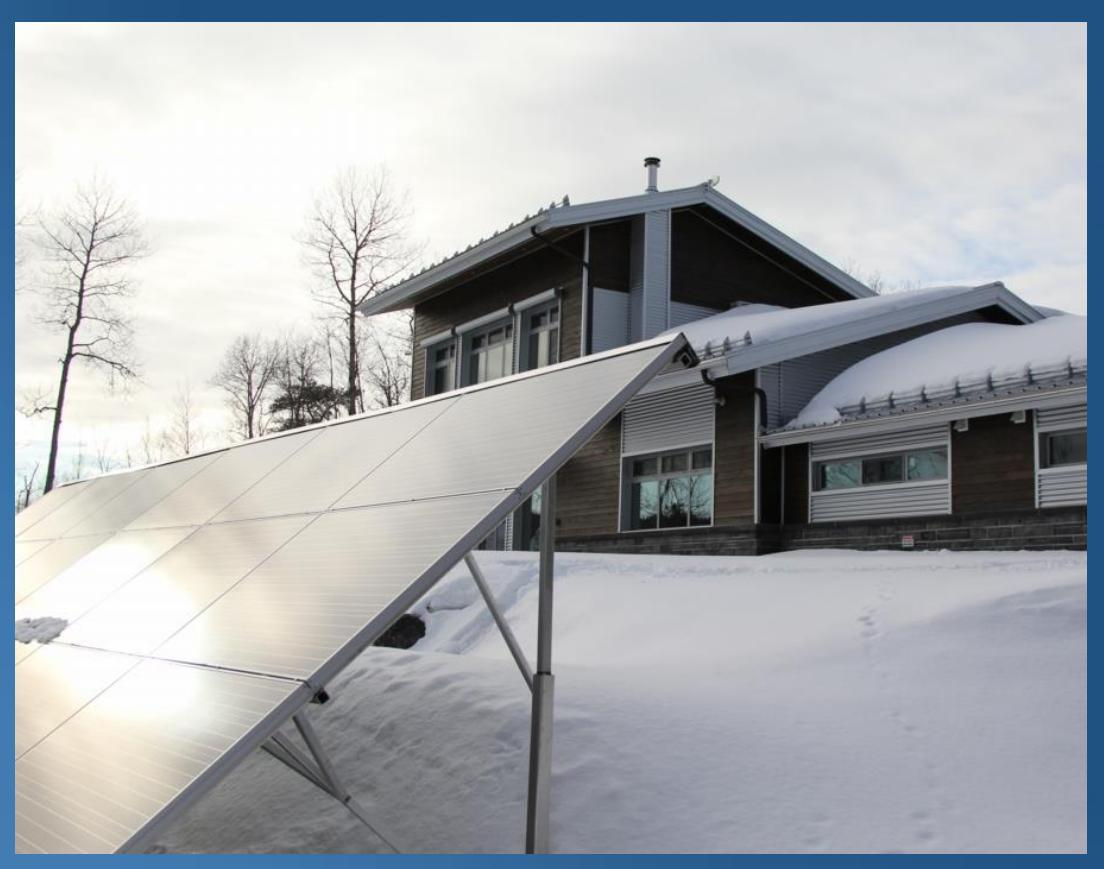
Solar array in front of the Kenogami House. Photo: Alain Hamel

- Solar electricity
  - 5.4 kW array (currently)
  - Will expand to 8 kW for net-zero
- Battery back-up
  - 16 deep-cycle batteries store 475 amp-hours
  - Critical-load circuit powers electrical components of propane heating system, water pump, refrigerator, HRV, internet, and one outlet and two USB ports per room

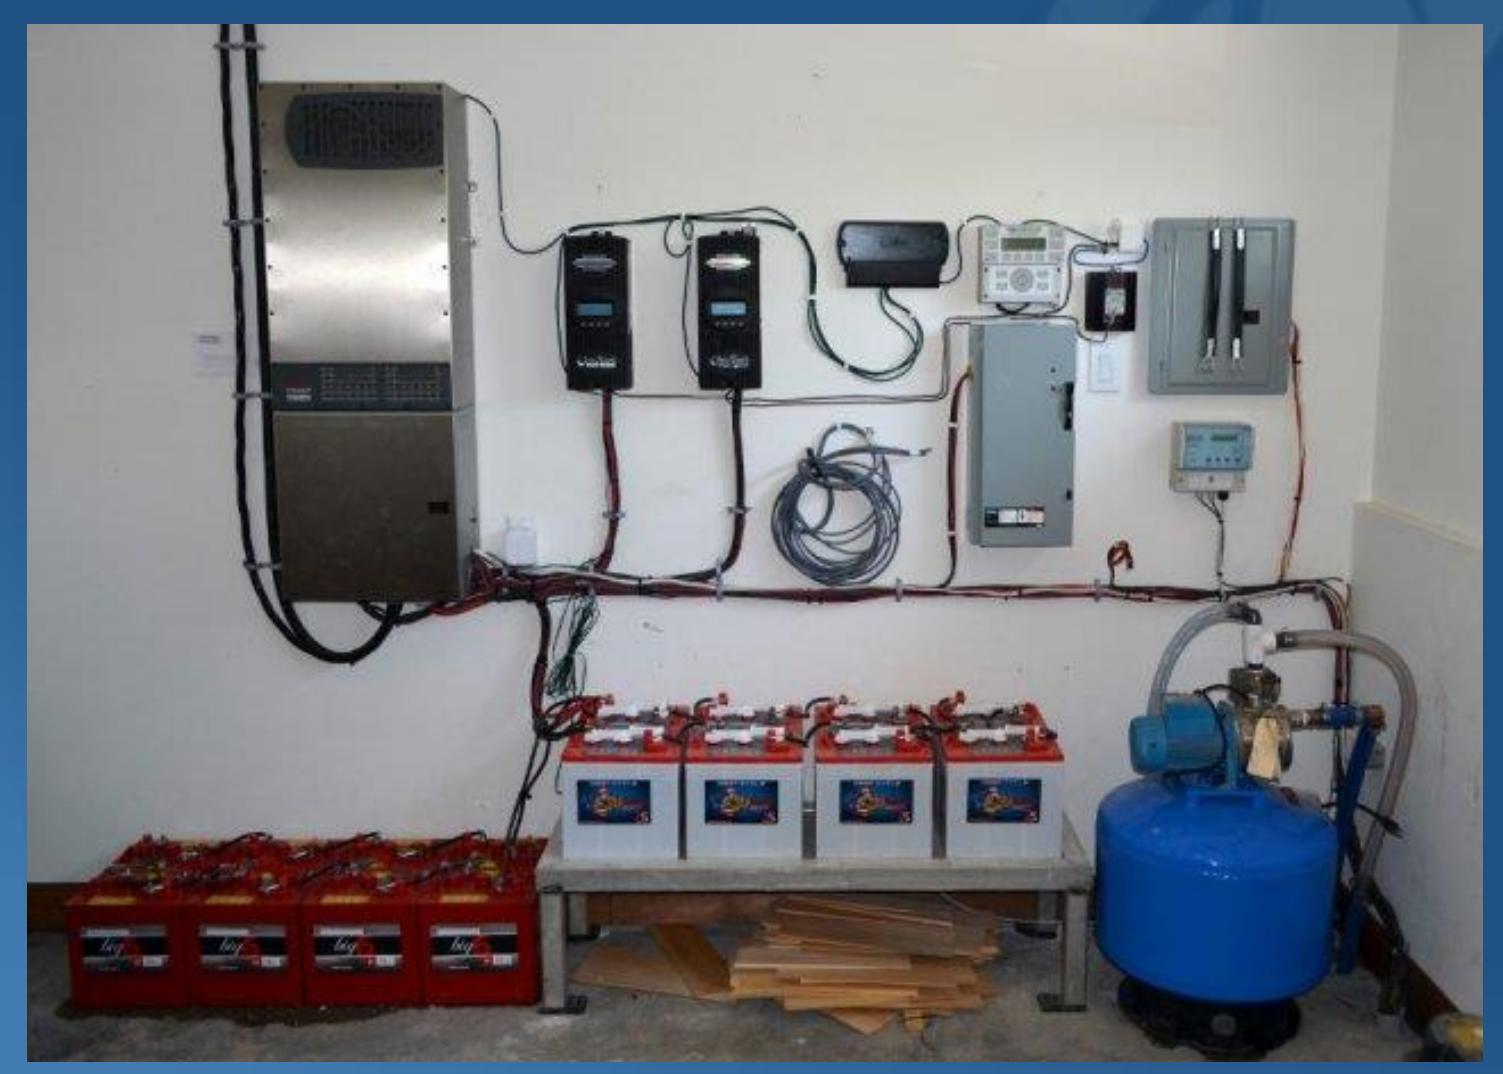
Inverter, batteries, and controls - Kenogami House. Photo: Alain Hamel

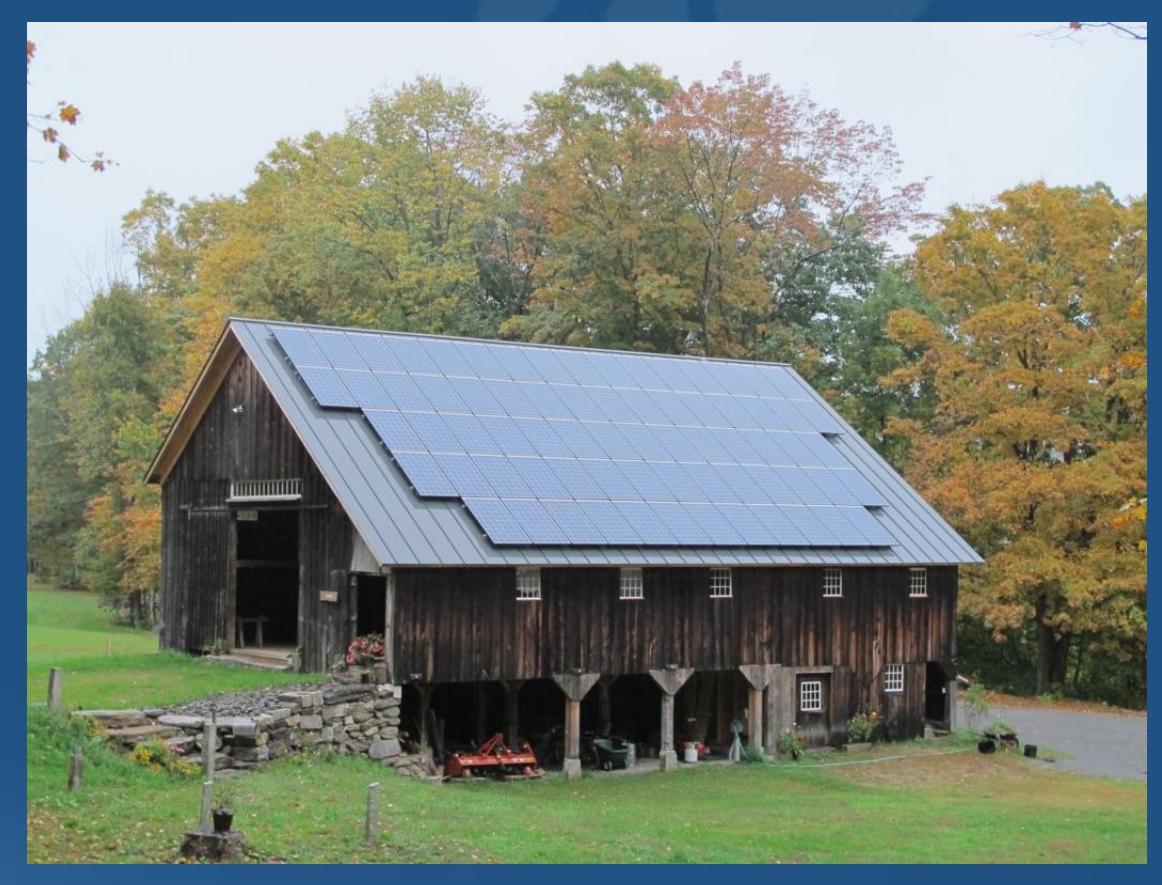
- 18 kW "group-netmetered" system
  - We own 12 kW, a neighbor owns 6 kW
- Grid-connected system that we can still draw power from during an outage
- Only daytime power, though

18 kW group-net-metered solar array on our restored 1812 barn in Dummerston - photo: Alex Wilson

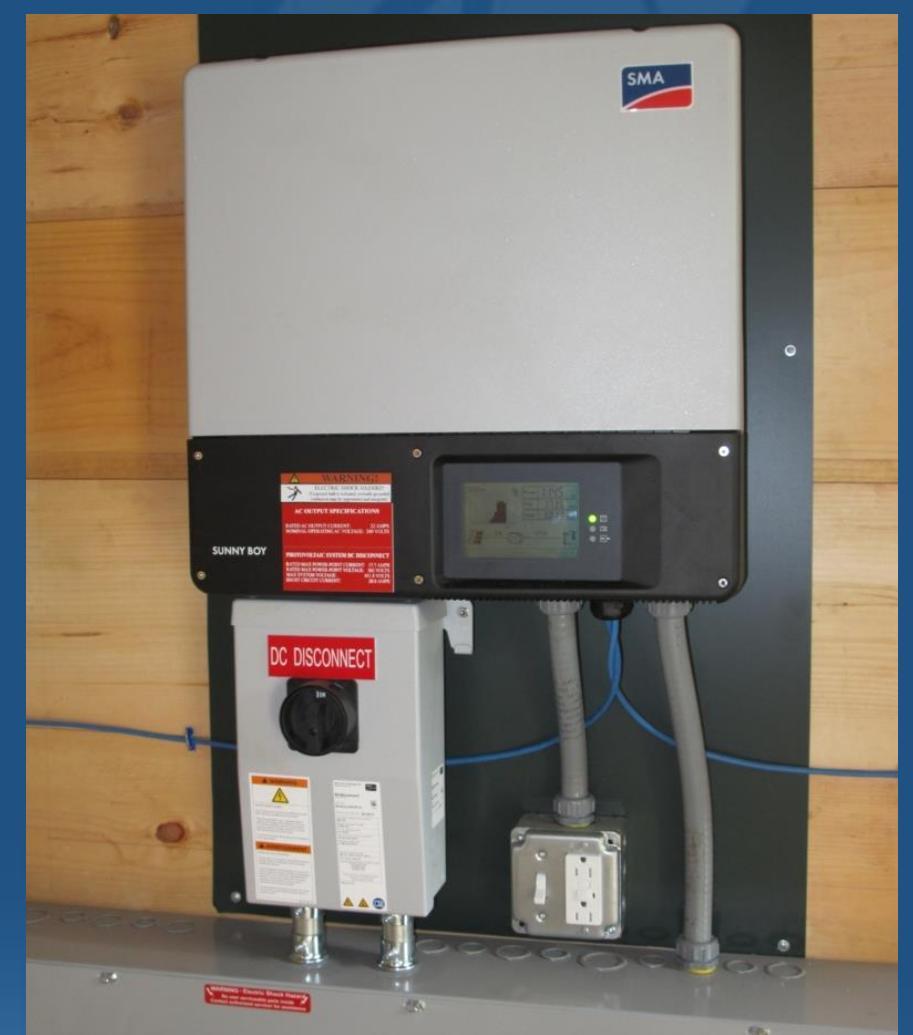
- New SMA transformerless inverter
- Access to solar electricity when the grid is down and the sun is out
- Outlet can provide up to about 15 amps
- Ideal for charging cell phones, laptop computers, powering cable modem and wireless router
- "Soft-start" refrigerator or freezer using extension cord
